# Manhole Inspection Summary

Manhole # S45G\_\_021MH

**Location** Address: **Pratt**

Cross Street: **Castle**

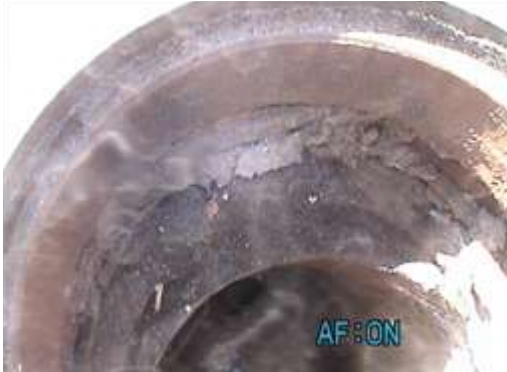
Defect 2

Frame leaks

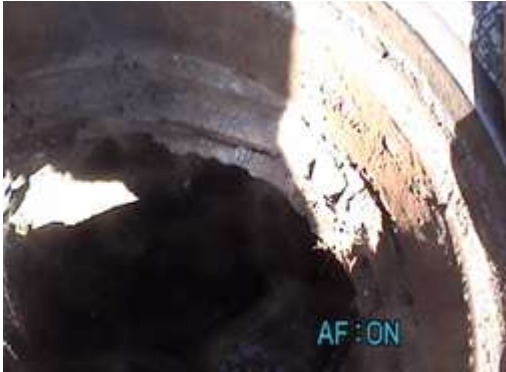
Defect 1

Infiltration

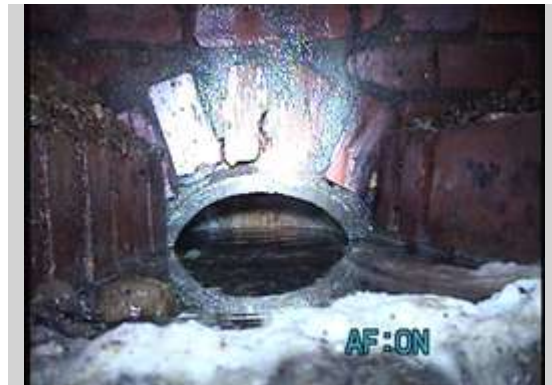
Drop In @ 3 O'Clock

Drop: **Inside** Rod and Bar  
Angled: **Yes** Reading: **11.40** (ft.)  
Inv Depth: **12.40** (ft.)  
Drop Condition: **Clogged**
